## PRØVNINGSRAPPORT

I5-848  
ID 970041

*testing of sandwich elements* comprising a core of mineral wool with a metal plate on each side has been performed on the terms mentioned overleaf. The elements are used for acoustic protection outdoors and the purpose of the test was to assess the influence of wethering on the performance of the elements as regards cohesion.

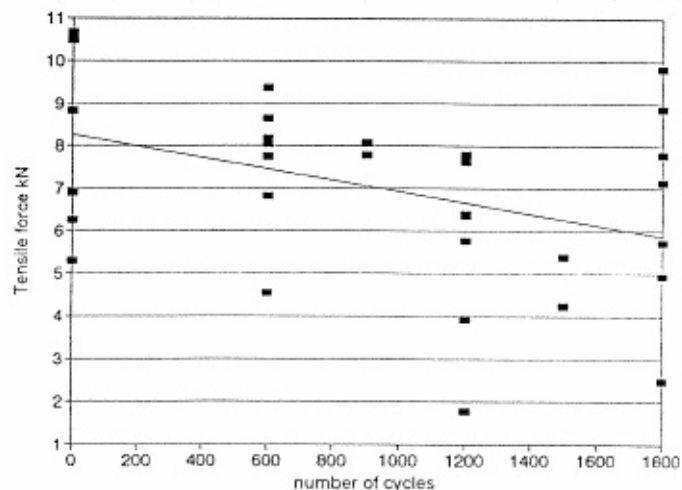
The results of the tests are shown in the scheme on the following page. The Figure below is showing the max. tensile force for each individual test specimen and the regression line for the tensile strength as a function of the number of ageing cycles. There is not distinguished between values for steel and values for aluminium, as they are very similar. The actual plate material is indicated with an s and an a respectively in the column "cycles".

The mean tensile strength for unexposed specimens is 8,26 kN. This value decreases according to the regression line with  $1.3 \pm .6$  N per ageing cycle ( $0.0013 \text{ kN} \pm .0006 \text{ kN}$ ). The test results for the individual specimens are shown on the curves in appendix 1.
